September 11, 2020
DR-4473-PR NR 42
News Desk Email: FEMA-newsdeskpr@fema.dhs.gov
FEMA News Desk: (866) 366-8807

News Release

Back Home Safer and Stronger after a Life-Changing Earthquake

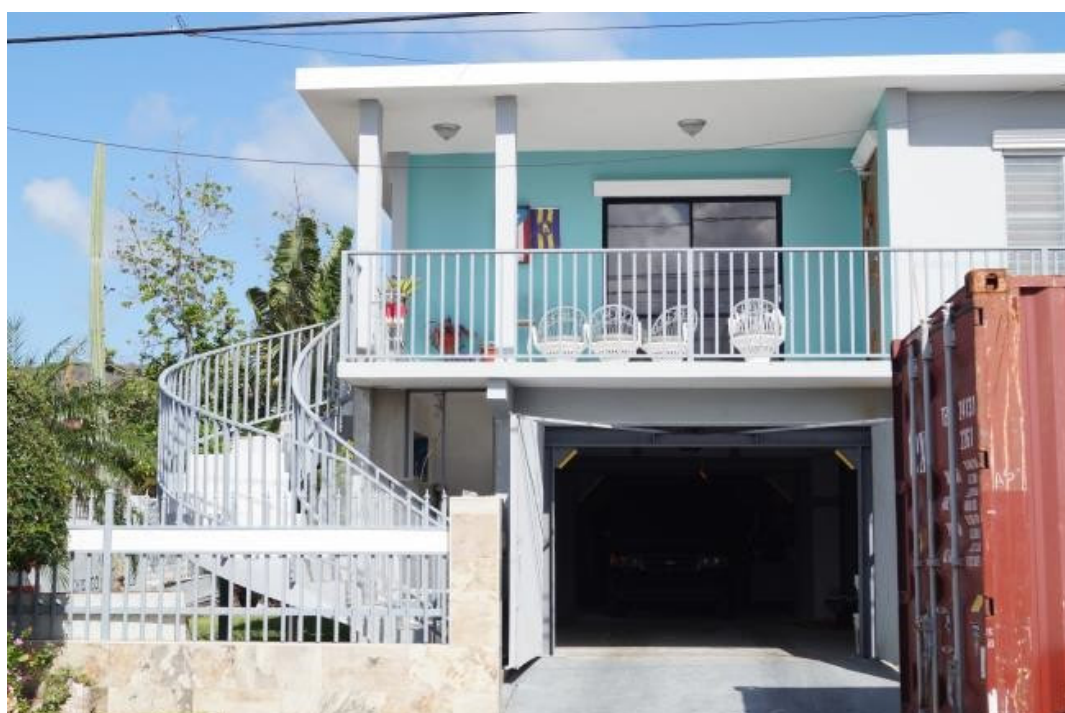
Guánica, Puerto Rico – The Nazario home is safe and welcoming again after repairs are completed to remedy extensive damage from the Jan. 7 earthquakes. The home was rebuilt to modern specifications with guidance from municipal authorities. (FEMA Photo/Rita Alcalá)

They contacted a structural engineer and a licensed contractor, who concluded that the structure and the home could be rebuilt using improved techniques like hydraulic jacks, iron beams and 8-inch thick retaining walls.

Over the next few months, a stronger version of their house emerged from the broken pieces. The upper floor was raised by installing 27 “H columns” run through the foundation slab and set 2 inches deep into the ground. Seventeen horizontal “H beams” were mounted on the columns. Retention walls were added to substitute for the original concrete block walls. Twelve fiber cement siding panels were added for strength.
